ERDC/CHL TR-00-1

Coastal and Hydraulics Laboratory

## **Demonstration Erosion Control Project Monitoring Program**

### **Fiscal Year 1995 Report**

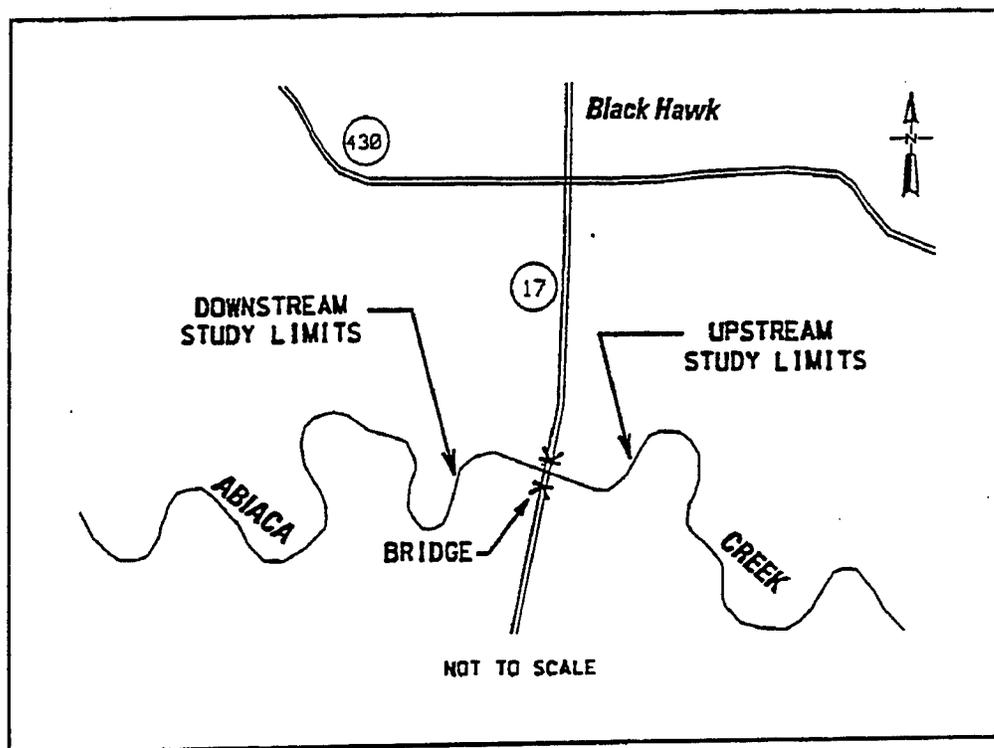
Figure 8. Abiaca Creek, site #3

BURBANK results (Table 2) confirm that the banks are stable for a friction angle of  $14.7^{\circ}$ . With assumed saturated bank conditions, a friction angle of zero, only 6% of the bank is at risk. If 3 feet of degradation is assumed to occur, the risk of bank failure has decreased from 19% in 1993 to 12% in 1995. Comparison of the thalweg surveys indicate

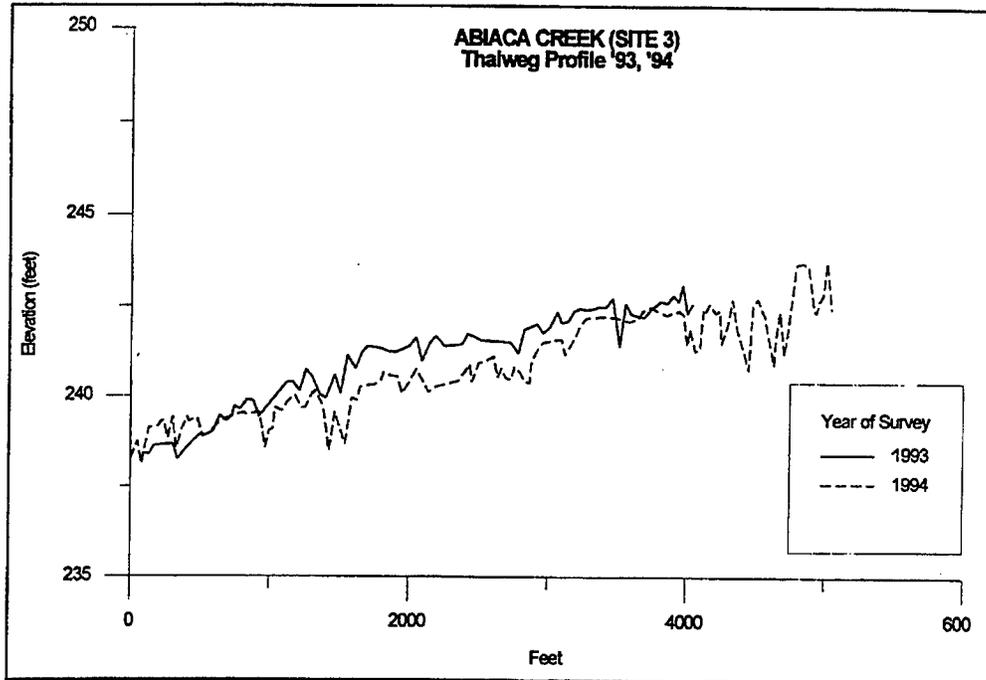
Figure 9. Thalweg profiles for Abiaca Creek, site #3

no significant aggradation or degradation trend (Figure 9). The reach is generally stable with no man-made bank or grade stabilization.

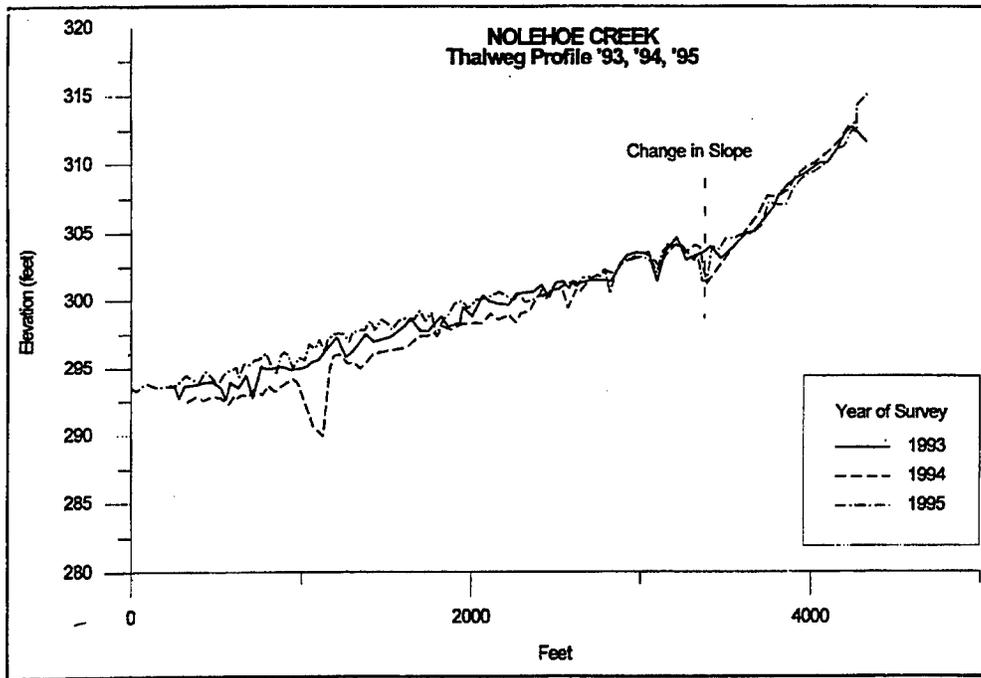
Figure 39. Thalweg profiles for Nolehoe Creek, site #7

The thalweg profile indicates that the lower Segment 1 has aggraded slightly and that the upper portion of the segment has changed little (Figure 39). Segment 1 has been classified as CEM 4, Segment 2 is classified as CEM 2. Segment 2, upstream of the break in slope, is very steep and dynamic. Segment 2 concentration is more than 4 times Segment 1, and continuing urbanization will accelerate the upstream degradation, which will place the upstream box culverts at risk. Channelization of Segment 2 to include grade control, and similar treatment for the tributary entering from the north at the break in slope should be considered. Property owner permission may be a major impediment to any future work.

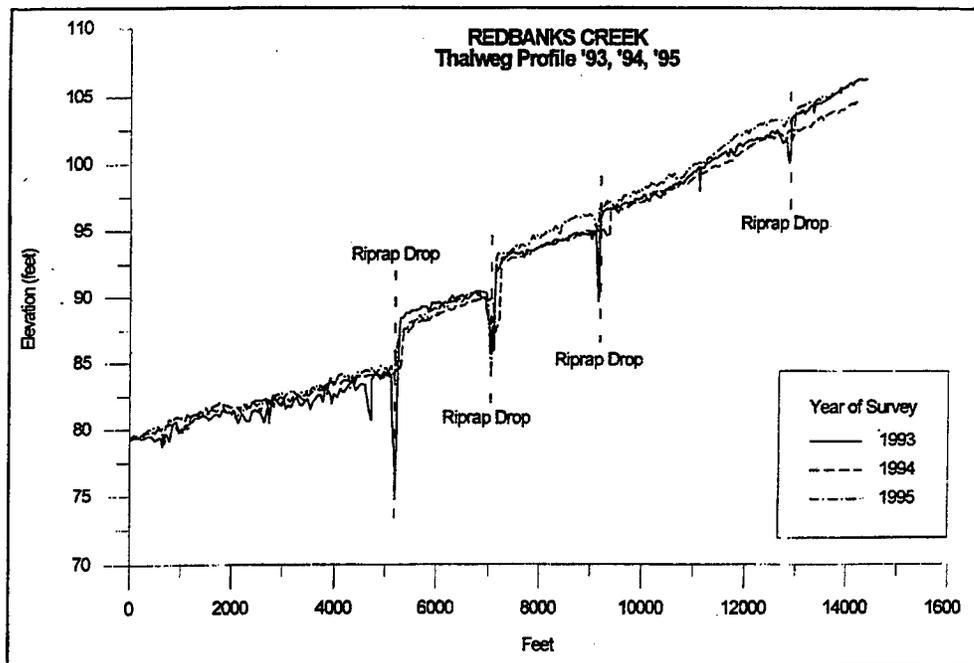
Figure 45. Thalweg profiles for Redbanks Creek, site #9

Bank stability increases in the upstream direction. Using the zero friction angle assumption, 100% of the banks are at risk at the downstream Segment 1 and only 8% of the banks are unstable in Segment 5. This improvement in stability is consistent with the use of serial grade control structures to reduce bank height. Consideration should be given to refurbishing the existing Chevron weirs, perhaps by rebuilding and extending the structure length. Consideration should be given to additional structures downstream. The BURBANK results indicate that the existing weirs are important in maintaining bank stability.

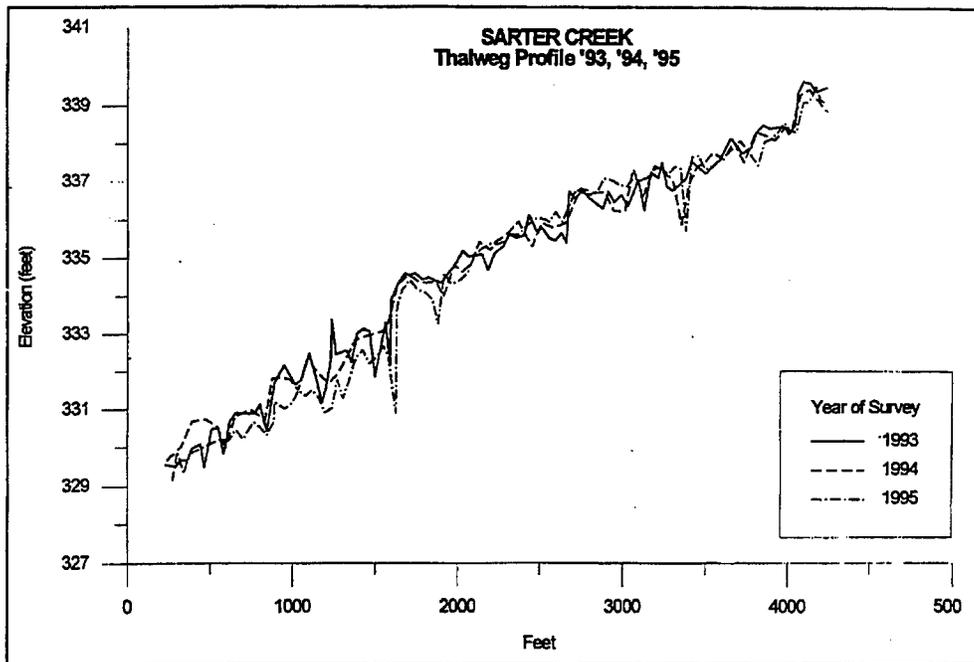
Figure 47. Thalweg profiles for Sarter Creek, site #15

The 1995 profile indicates continuing incision. Field inspection in November, 1995 confirmed several headcuts, and that numerous beaver dams are playing an important role in maintaining the stability of the channel. The channel ranges from a CEM 4 at the downstream extent to CEM 2 upstream, and has been given a CEM 3 designation overall. Riprap grade control should be considered for the site.

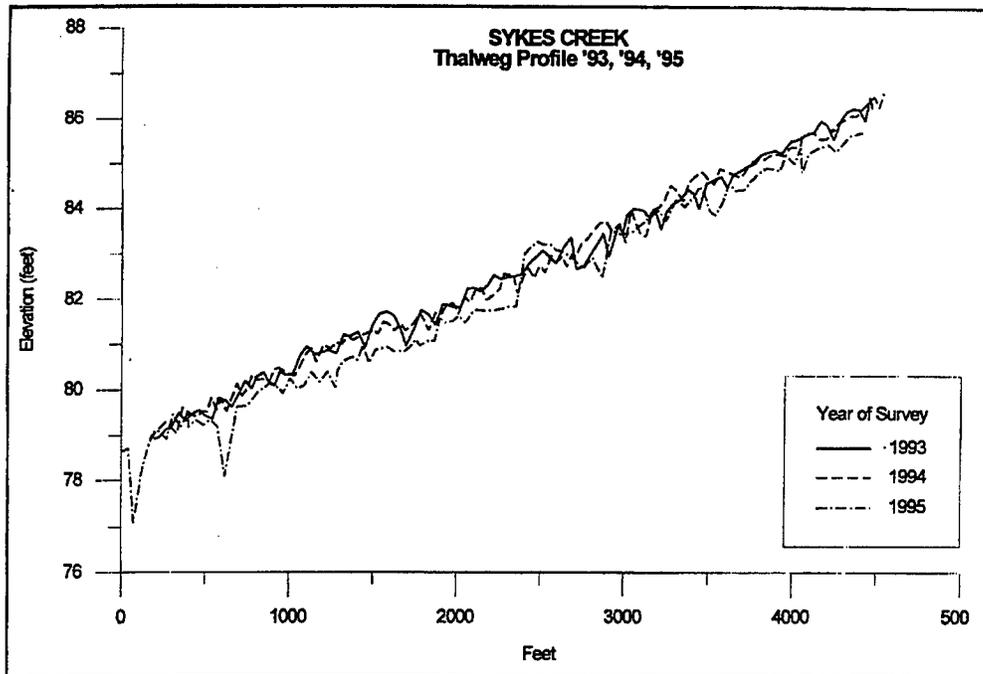
Figure 49. Thalweg profiles for Sykes Creek, site #17

The accompanying thalweg profile, shown in Figure 49, indicates that little change has occurred during the three year period, and by many indicators such as berm formation, depth of sand in the bed, and by thalweg comparison, the channel could be considered in quasi-equilibrium. However, comparison of the existing conditions to the slope and width required at minimum stream power for transport of 1000 mg/l indicates that the reach is transporting a high sediment load. The 1995, 2-year water surface slope is 211% of the minimum slope and the width is 71% of the width at minimum slope. In addition, BURBANK analysis indicates that approximately 40% of the channel banks are unstable if degradation occurs and the zero friction angle assumption is valid.

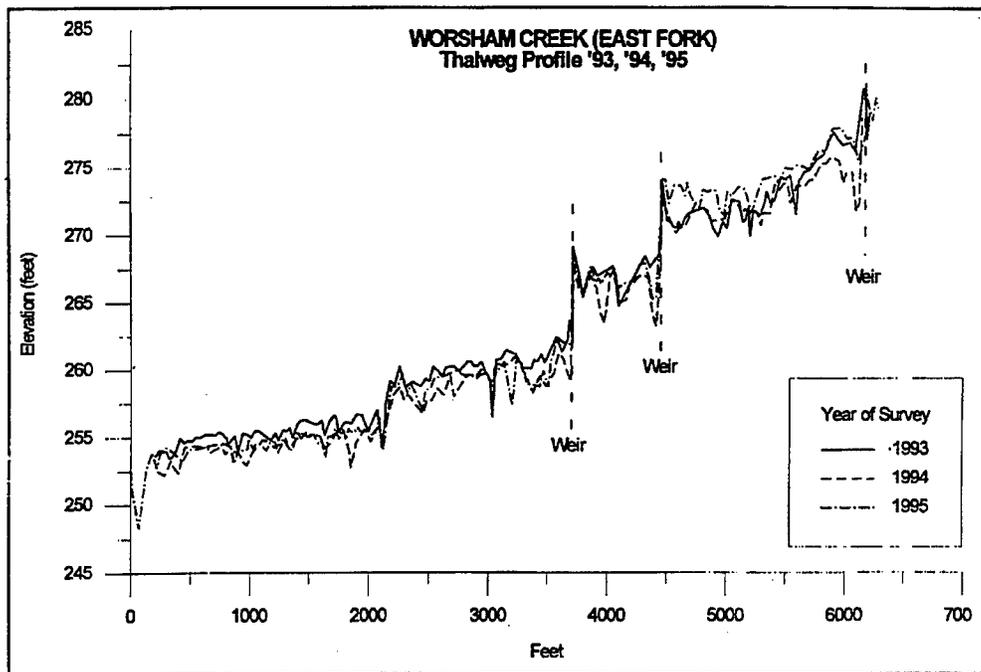
Figure 51. Thalweg Profiles for East Worsham Creek, site 18a

Upstream of No. 2 structure, in Segment 3, the 1995 survey indicates that significant aggradation has occurred. The upper portion of Segment 3 is a hard, erosion resistant clay that has changed little in the past four years. A beneficial effect of the upstream grade control structures can be realized by comparing the BURBANK analysis of the percentage of bank at risk for the zero friction angle condition in 1995. Grade control has raised the channel bed to reduce the percentage of bank unstable from 100% in Segment 1 to 5% in Segment 3. This is a significant improvement. However, the SAM results indicate that the 2-year slope in all segments remains very high at approximately 250% of the 1000 mg/l minimum slope. See Table 22 for summary results and Figure 51 for thalweg profiles of site 18a.
